Westerly Athletic Facilities Master Planning

Site Analysis and Evaluation

Volume One of Three

September 2017

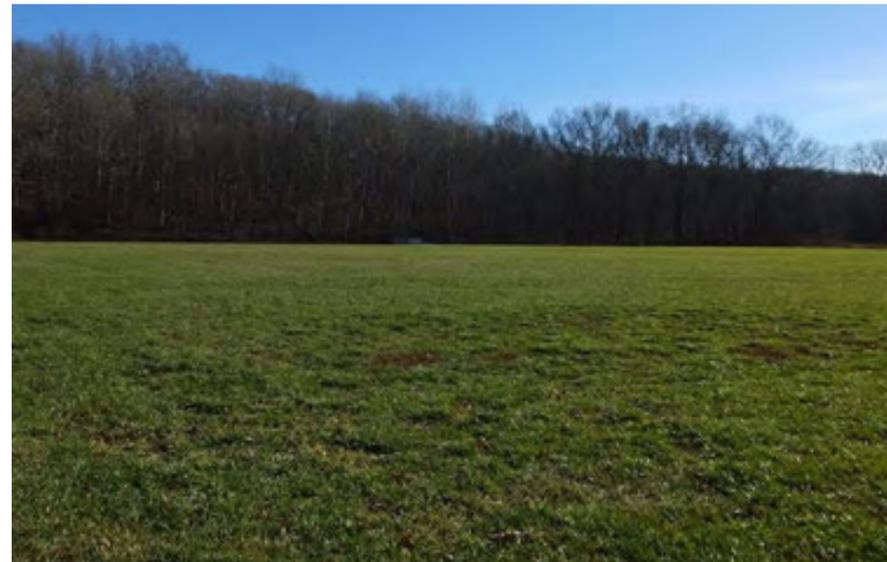
North Field

The grass at the north field is patchy with wear spots evident at highly-trafficked areas. The field has an east-west orientation, and the grade of the playing surface is uneven and falls off abruptly on the east edge of the field. This is indicative of a field that has been converted from farmland and that was never formally graded as a field.

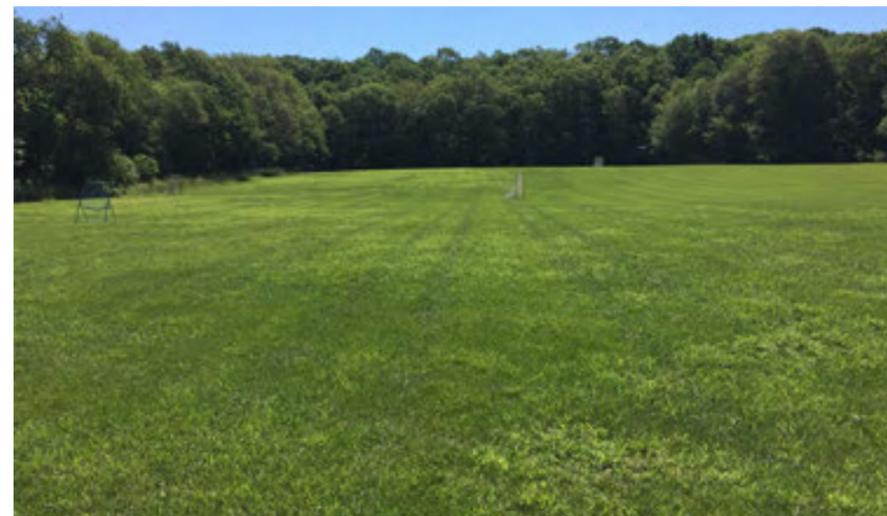
South Field

The conditions at the south field are similar to the north field. The grass is patchy with wear spots evident at highly-trafficked areas. The field has a north-south orientation and the grade of the playing surfaces undulates. This is indicative of a field that has been converted from farmland and that was never formally graded as an athletic field.

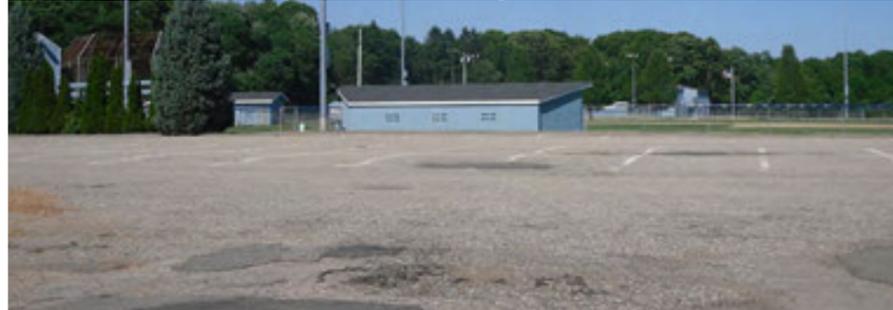
Main Parking Area

The main parking lot and baseball field are the first things you see upon entering the complex. As you continue along the access drive, you enter the second parking area by the softball fields. Both lots are in disrepair with inefficient layouts. The paved areas are striped.

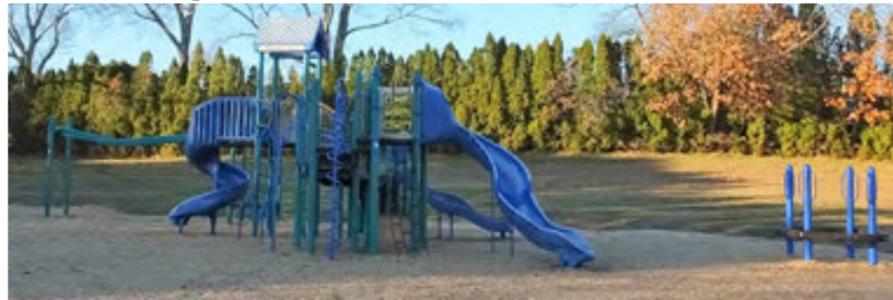
Play Structure

There is one main play structure with an accessory structure and two swing sets. There is an adjacent wooden pavilion to the east of the structures. These elements are in good condition.

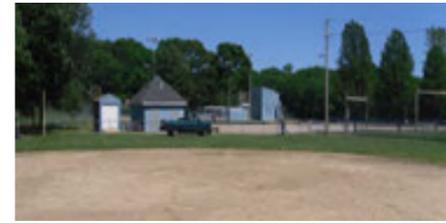
Little League Field

The “Little League” field grass is in good condition, while the infield shows signs of drainage issues. The outfield is truncated at left and right field. The players’ areas are in disrepair. There are two small bleachers provided.

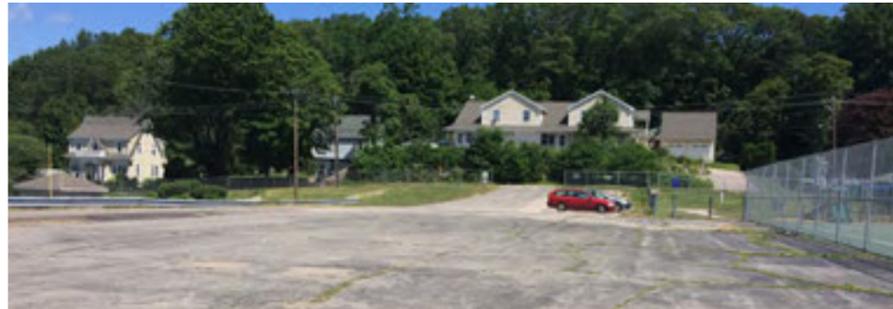
Upper Lot

The main parking lot is found at the main entrance off Mountain Avenue. There are a few striped spaces at the beginning of the upper lot and a few more at the lower lot. The pavement to the south of the upper lot is in disrepair. The lower lot is in fair condition and also paved and striped. There is a second gated entrance on Mountain Avenue that leads into the dirt/grass lot. There is a small building at the pedestrian entrance on High Street.

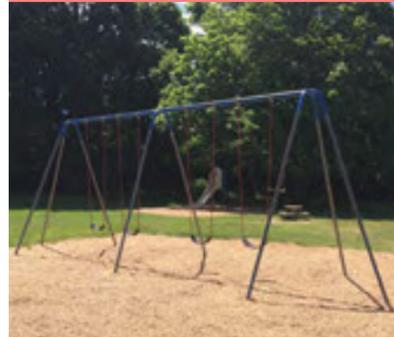
Swings

There is one main play structure with an accessory slide structure and two swing sets. There is an adjacent wooden pavilion to the north of the structures and an additional small pavilion to the east of the basketball court. These structures are in fair condition.

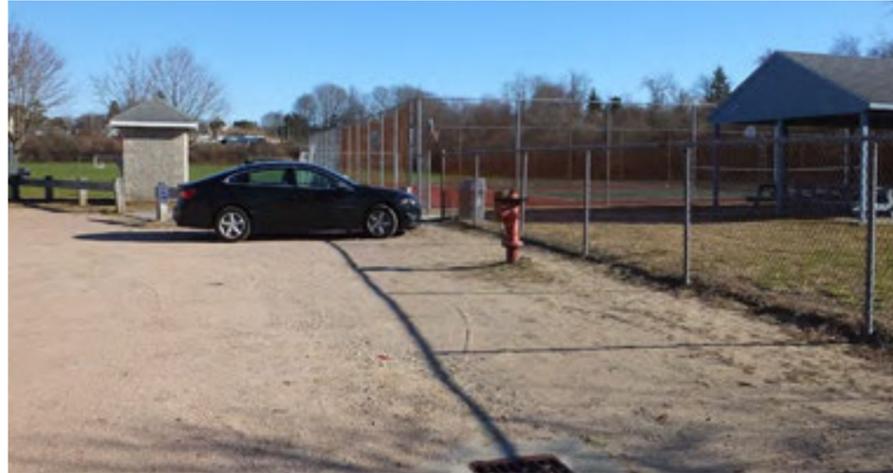
Parking Area

There are two entrances to the complex; the southern one is the main entrance. The parking area is dirt parking with wooden guardrail. The complex is surrounded by chain link fence. There is one main concessions/restroom building.

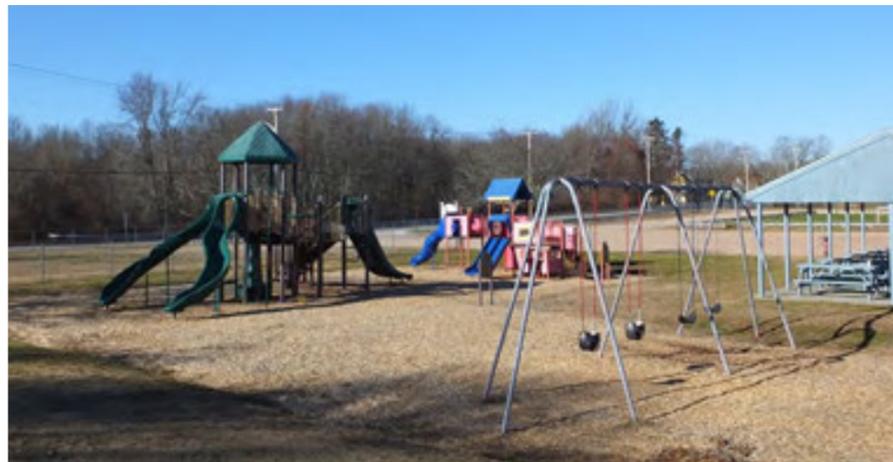
Play Area

There is a 5-12 play structure and a 2-5 play structure with a set of toddler swings and wood chip safety surface. These structures are in good condition. There is also an adjacent wooden pavilion which is in fair condition and an additional small pavilion to the north of the main building that is in poor condition. The main building on site is a masonry block combination concession/restroom storage building which is in good condition as well as a masonry block irrigation shed, both of which are at the front of the park, adjacent to parking.

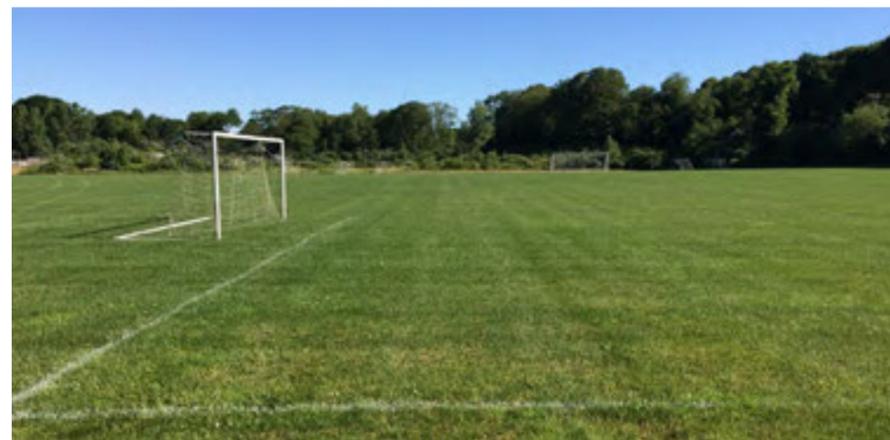
Soccer Fields

The fields of various sizes and orientations and are generally in good condition with consistent grading, a consistent stand of grass, and few bare spots. All the fields are irrigated. Wet areas are reported to the northeast and east of the fields. The fields are minimally crowned, but no drainage issues were evident.

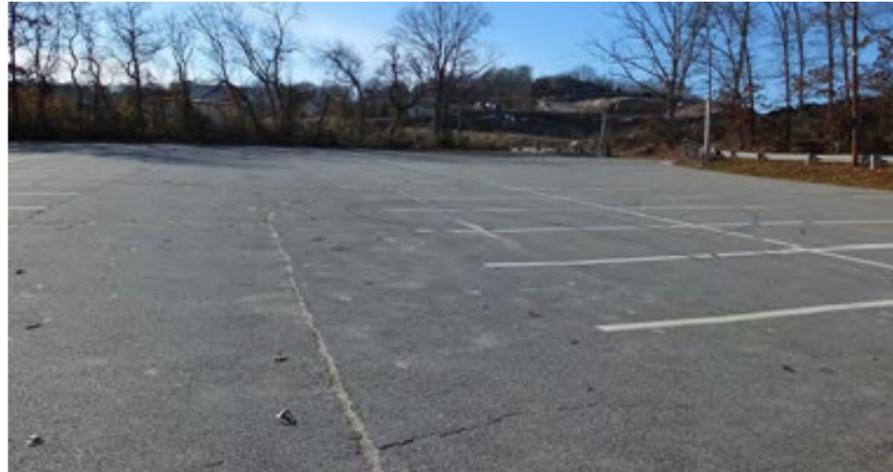
The gated entrance opens to a large paved and striped parking lot. The lot is in fair condition, however, the lot slopes and drains toward each corner of the field, causing washouts outside the end zones. The aisles between bays are not sufficient (only 18' wide) for 90° parking. There is a rusted metal guardrail which runs along the road and a rusted chain link fence which borders the field.

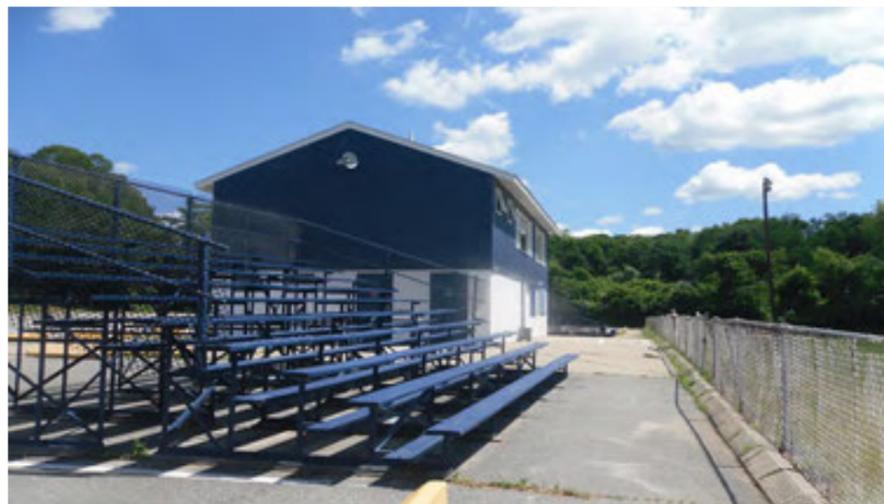
Spectator Area

A large concessions/restroom/press box building stands at the center of the site. It also serves as signage with a large bulldog painted on the northern face. There are also two large wooden/metal bleachers available to spectators. The bleachers do not meet current safety or accessibility codes. The building and bleachers are in fair condition and have been painted recently.

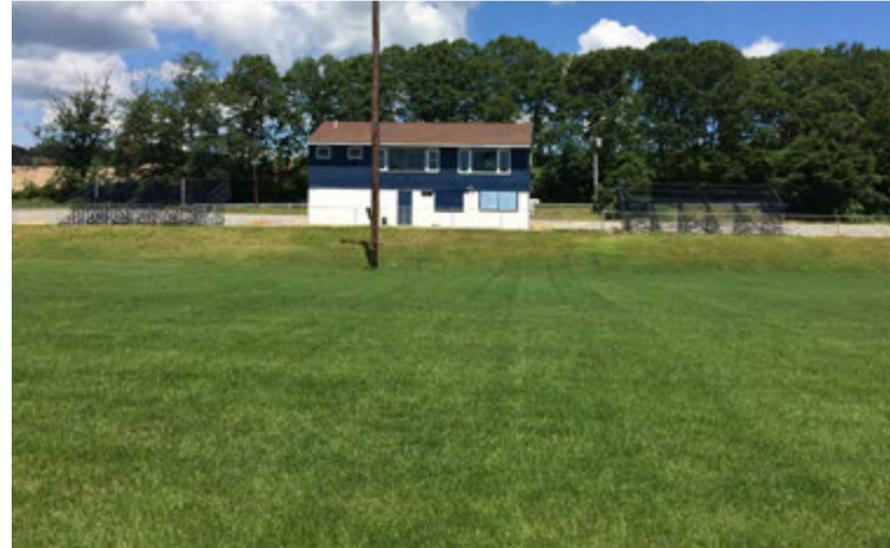
Football Field

The field is irrigated and lighted. The field itself is undersized for adult play. The field is properly crowned and grass at the field is in good condition. The football goal posts are older metal posts that have recently been repainted and are in fair condition. The scoreboard has been recently replaced. The field lighting is out-of-date and in poor condition. There is no spectator lighting provided other than that on the building.

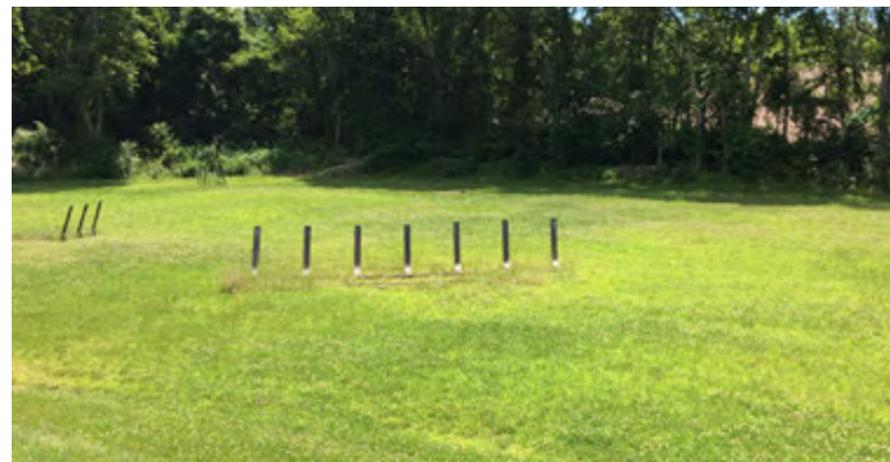
Practice Field

The grass at the practice field is weedy with little actual grass and is in poor condition. The practice field is unirrigated and the grade is very inconsistent. It appears to puddle in spots. There is a storage shed to the east of this area that is in good condition.

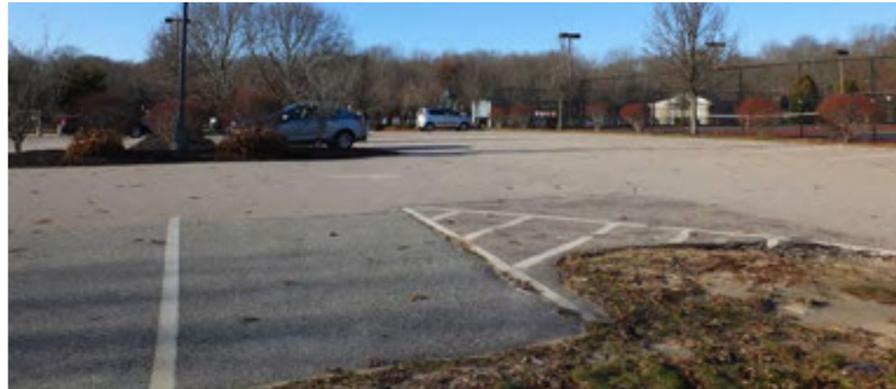
Parking Area

The main entrance to the park opens to a paved and striped parking lot with a drop-off area. It is in fair condition with landscaped islands. The second entrance opens to a small dirt parking area that is surrounded by wooden posts. There is an informational kiosk at the park main entrance.

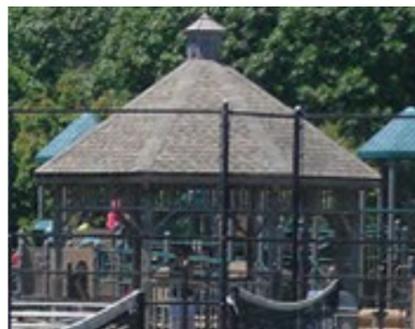
Gazebo

There is a 5-12 play structure and a 2-5 play structure with two swing sets. There is also an adjacent wooden gazebo. Play areas are enclosed with fencing to limit access. Adjacent to the play area is a small seating area as well as a small children's garden. These areas are well-maintained and are in good condition.

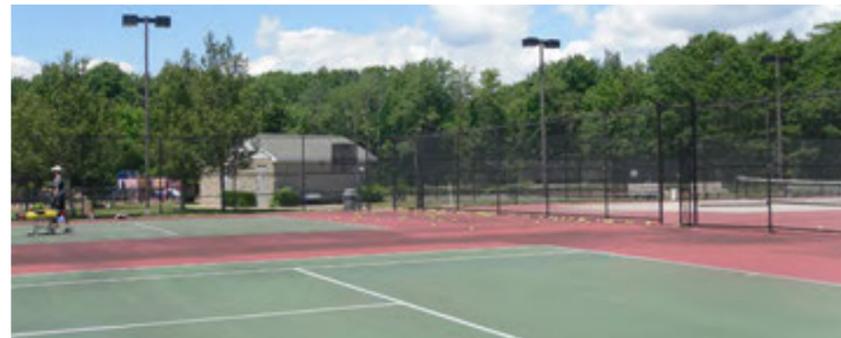
Main Courts

The west courts are in generally better condition. The west courts are also surrounded by fencing and the surface is in good condition. The hardware and nets are in good condition, however, the center straps are in disrepair. There are two benches at these courts.

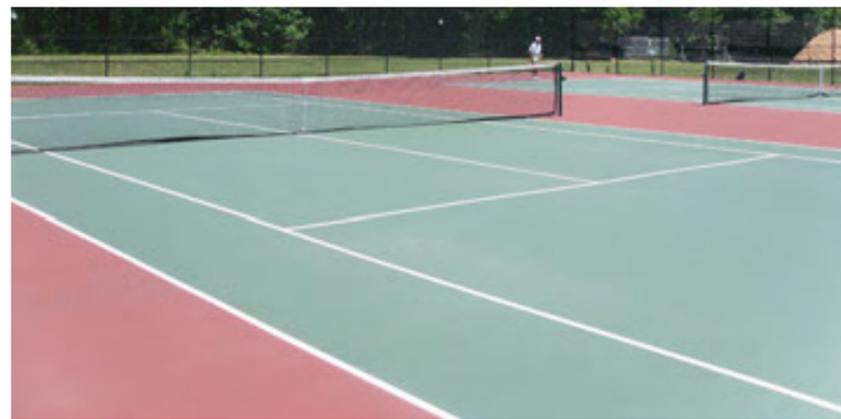
There are two banks of tennis courts: an older bank of four courts near the street (the main courts) and a newer bank of two courts to the west. The main courts are surrounded by chain link fence and are lit with parking lot lights on poles. The surfacing is in fair condition with some cracking and thin or bare spots and is need of a re-coating. The hardware and nets are in good condition. The fencing at these courts is light duty and is in fair condition with some rust and bent hardware. The seating and bleachers at these courts are in good condition.

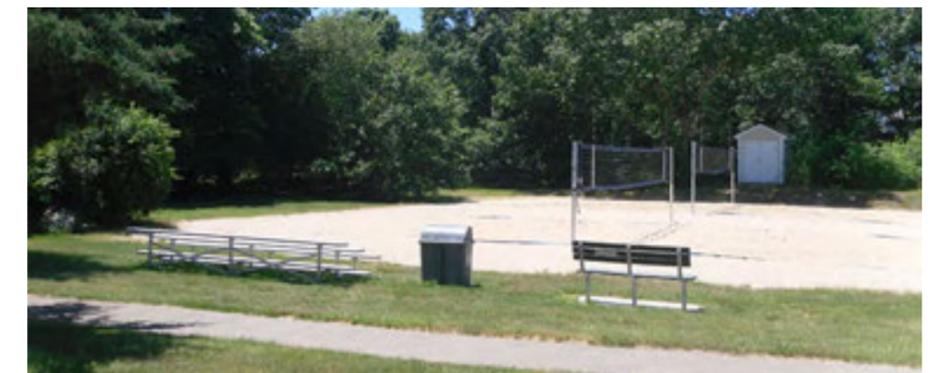
Volleyball Courts

The two sets of beach volleyball courts (4 total) are to the west of the entrance. These sand courts are striped with netting installed. There is some encroachment of grass to the sand, but otherwise the sand is in good condition. The southern courts have more formal seating and the northern courts have a few large boulders for seating near the sidelines.

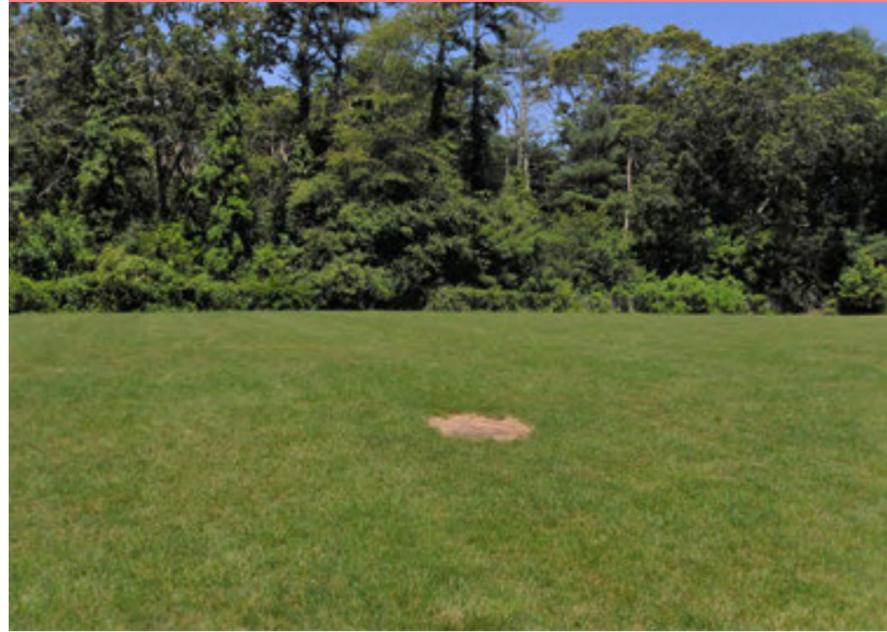
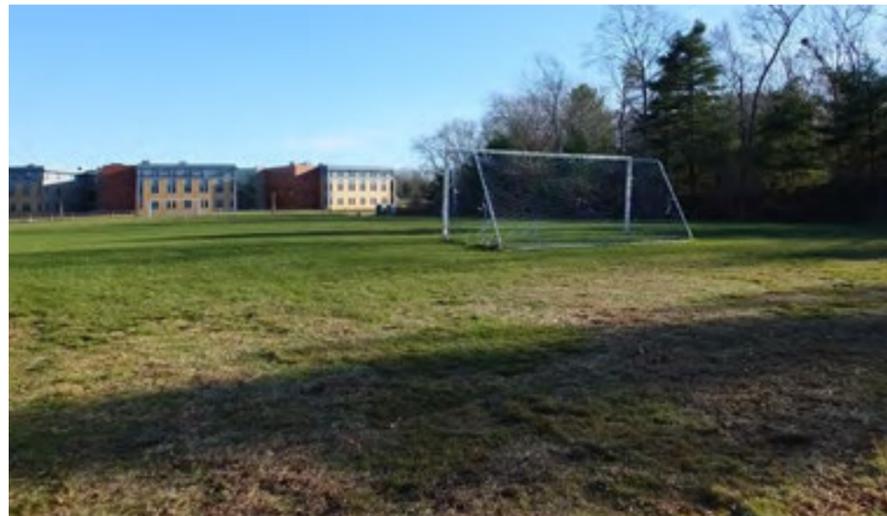
Typical Field Conditions

The grass at the field is patchy and shows patterns of wear. The grade of the field is inconsistent with a large crown appropriate for natural turf. The field is in fair condition with some bare spots and signs of puddling at the sidelines. Soils appear gravelly and compacted. Soil tests reveal low turf nutrient levels. There have been reports of poorly-operating irrigation, however, this was not evident during our walk-through. There were a few players benches on the south side of the field and porta-potties located at the field entrance. No accessible path is provided to the area of play.

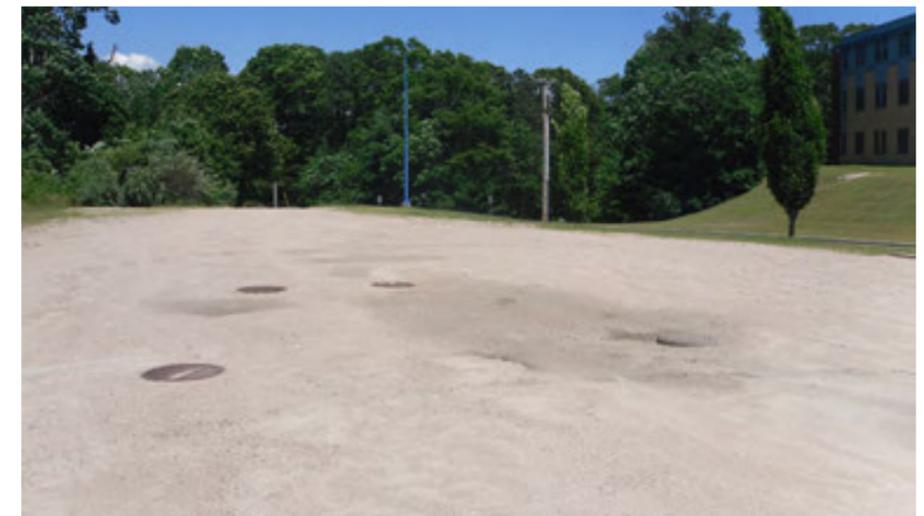
Gravel Parking at Soccer

The main entrance to the school is off a traffic light-controlled stop along a busy road. There is a gravel access drive off the main driveway that leads to a gravel parking area next to the soccer field which shows evidence of puddling and drainage issues. Accessible parking has been provided at the field entrance. This entrance and parking area has suffered considerable erosion and is in poor condition.

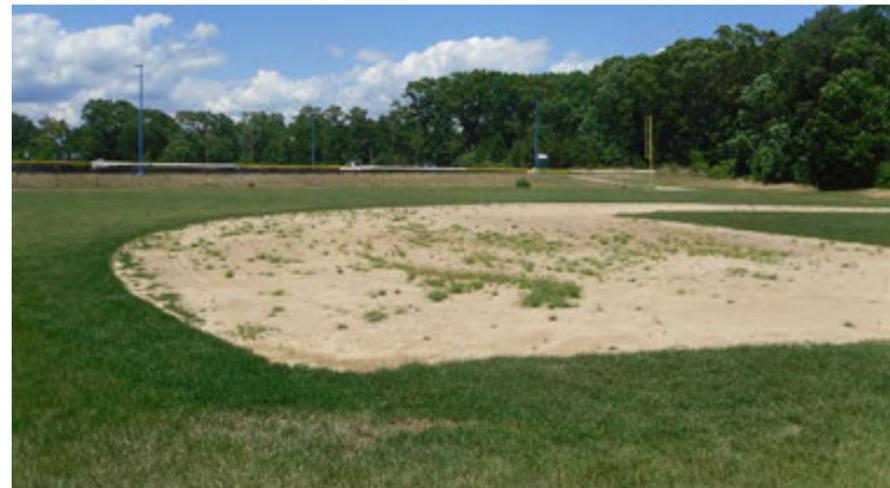
Infield Conditions

The grass at the baseball field is in fair condition, although it is dry since the backflow preventer is not currently working for the irrigation system. A gravel warning strip is provided at the outfield fence. There is one set of bleachers at the field which do not meet current safety standards (due to the lack of guard rail at back). There is also a porta-potty. There are signs of drainage issues along the access path on the first base line, at home plate, and at both players' areas. There is no accessible path to the field, and the grade drops off steeply behind the backstop and players' benches, limiting usable space outside the field of play.

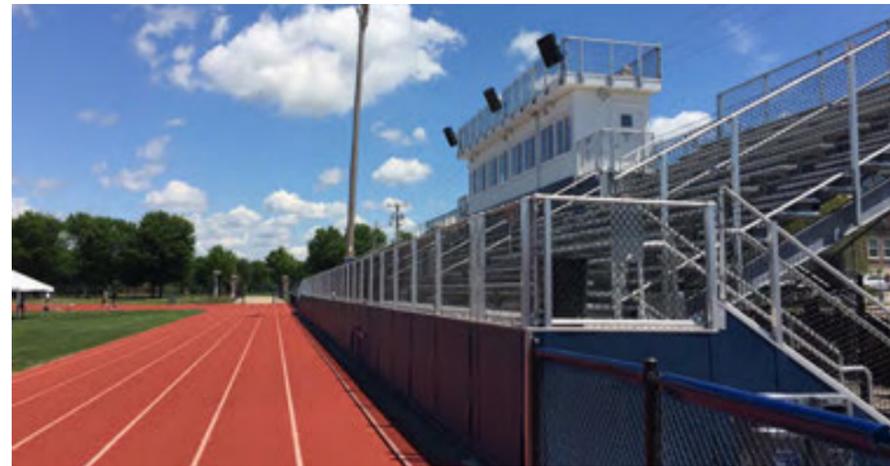
Home Bleachers

Augeri field is the town's main stadium/event venue and has been in this location for over 50 years. The complex includes a running track, natural turf game field, older field lighting, visitor bleachers, home bleachers, concessions, restrooms, and pressbox. The facility is completely fenced off and gated. Usage of the field is strictly controlled by the school to prevent over-usage, however the condition of the field remains poor. The field is fully irrigated. The grass at the field is replaced with new sod annually due to recurring turf conditions. The field surface is irregular dips and breaks in grade and pitch. For soccer or lacrosse, the field area is narrow and safety run-outs overlap with the track. For wider fields, drainage structures are exposed in the area of play. The football goal posts are older and are painted over. The field has little surface drainage. Underdrainage has been added over time where poor drainage conditions are observed. Drainage outfalls to the slope south facing Route 1 and into the south parking lot at Babcock Middle School.

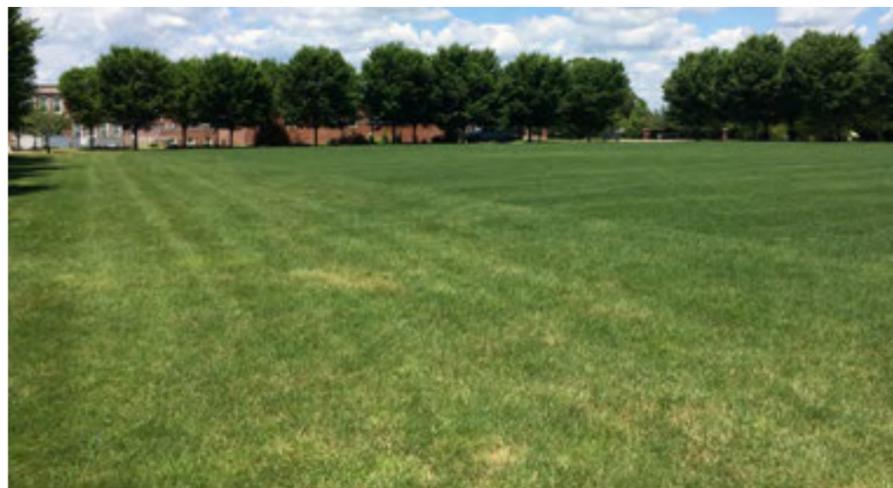
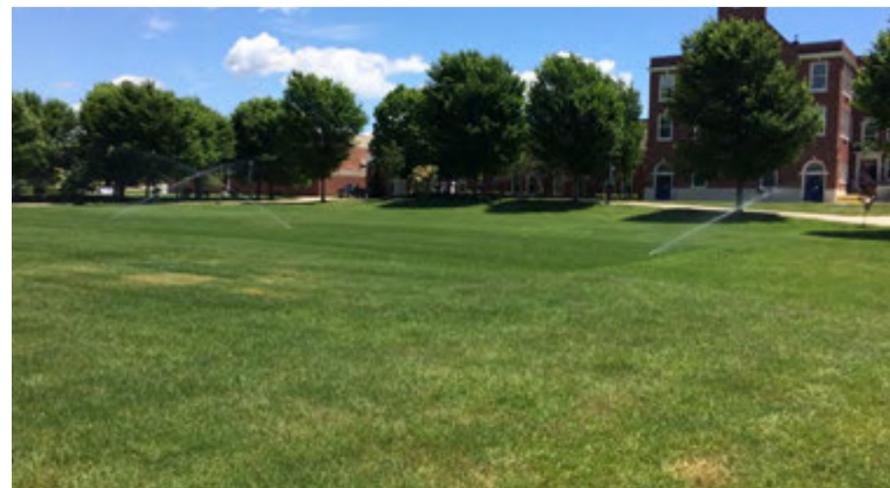
Typical Conditions

The Quad Field is in the center of campus. The field area is surrounded by a tree-lined (Japanese Zelkova) concrete walkway which frames the field and forms a well-defined space. Lawn areas are fully irrigated. The grass at the Quad is replaced regularly with sod due to the amount of use on the field throughout the year. The surface slopes east to west with a small crown. Surface drainage is provided at the perimeter. The space is open with minimal fencing and is not provided with any fixed athletic amenities.

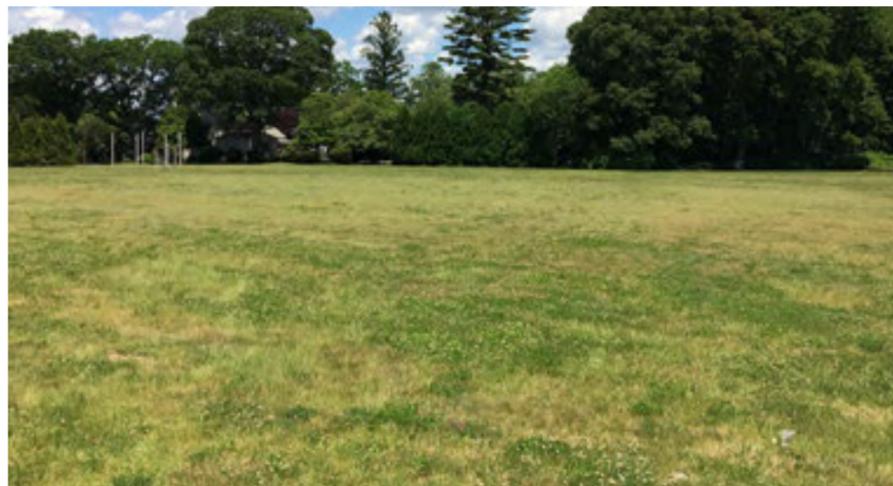
Typical Conditions

The practice field is designed as the home of the throwing events for track and field, however it is also regularly used for freshman football practice. The area is not irrigated and the grass at the Quad is in poor condition with many weeds, sparse coverage, and compaction. The surface is irregular and slopes to the north. Amenities on this field need repair and care, including the practice goal and throwing events amenities.
